TS-PIC-9805549R/9905549R
November 1998

AERIAL PHOTOGRAPHIC ANALYSIS MIDWEST METALLICS SITE Summit, Illinois

S. A. Shepard
Environmental Services Division
Lockheed Environmental Systems & Technologies Co.
Las Vegas, Nevada 89119

J. L. Bozik
Landscape Ecology Branch
Environmental Sciences Division
Las Vegas, Nevada 89193-3478

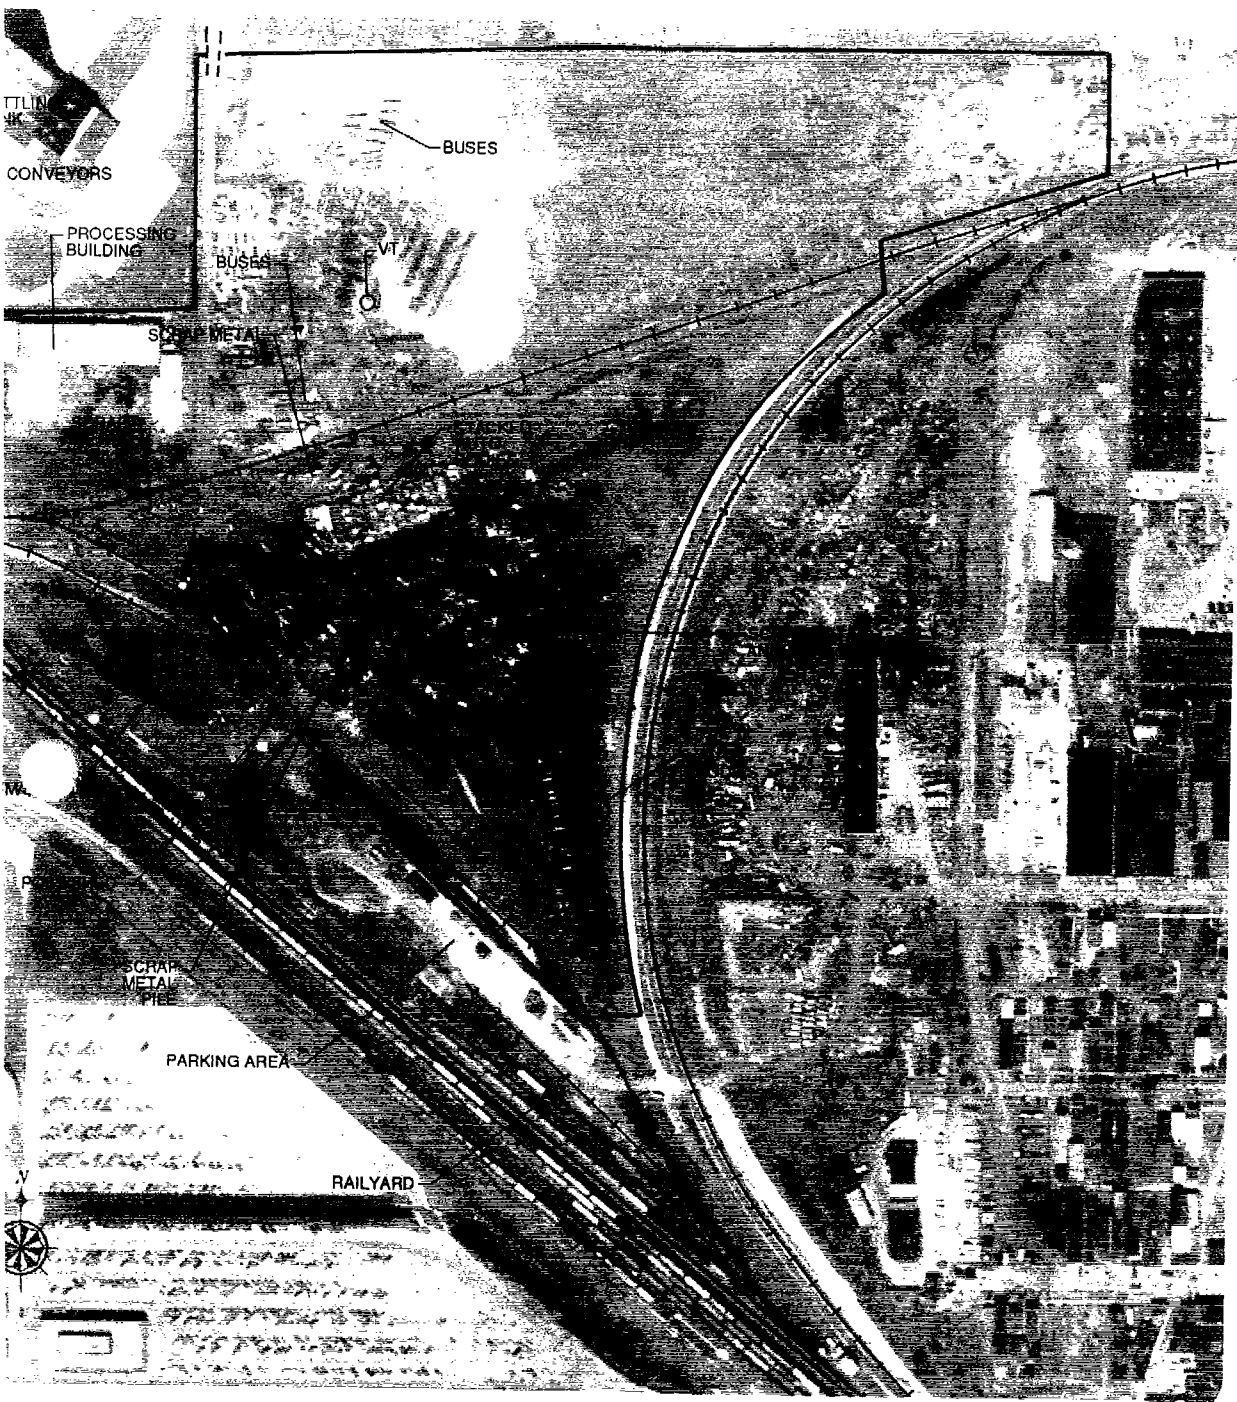
APRIL 7, 1976 (FIGURE 3)

The site appears to be in operation. The features observed in the operations on site include a processing building, conveyors, and a settling tank. These features remain visible and active throughout the study period and will no longer be discussed or annotated. A liquid-filled impoundment (IM-1/SL) is located at the southwest corner of the site. A parking area with vehicles, a railyard, and an access road are all located southwest of the site boundary.

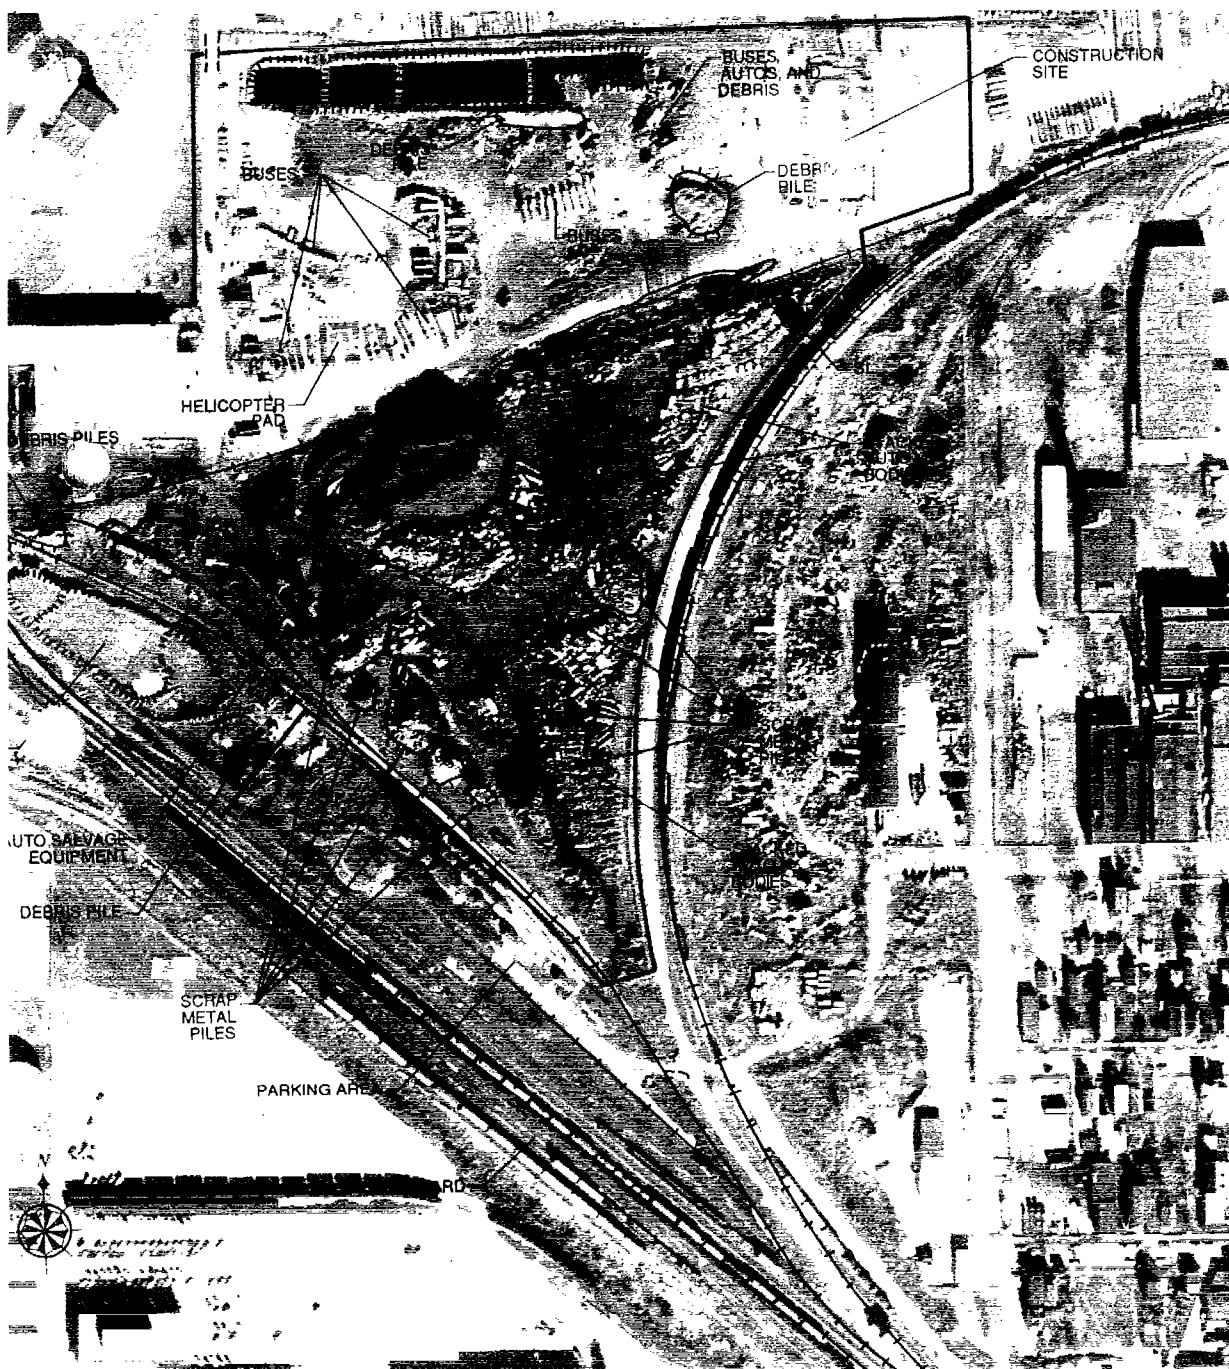
NOVEMBER 22, 1980 (FIGURE 4)

The site continues to be in operation. A liquid-filled impoundment (IM-2/SL) is present along the northern boundary of the site. A construction site is present at the northeast corner of the site. The liquid-filled impoundment IM-1/SL has increased in size since 1976 and now contains three cells. Another dry impoundment (IM-3) is present north of the automobile salvage equipment. Several areas of standing liquid (SL) have formed in the locations of depressions on the site. These areas of standing liquid will be annotated but not discussed.

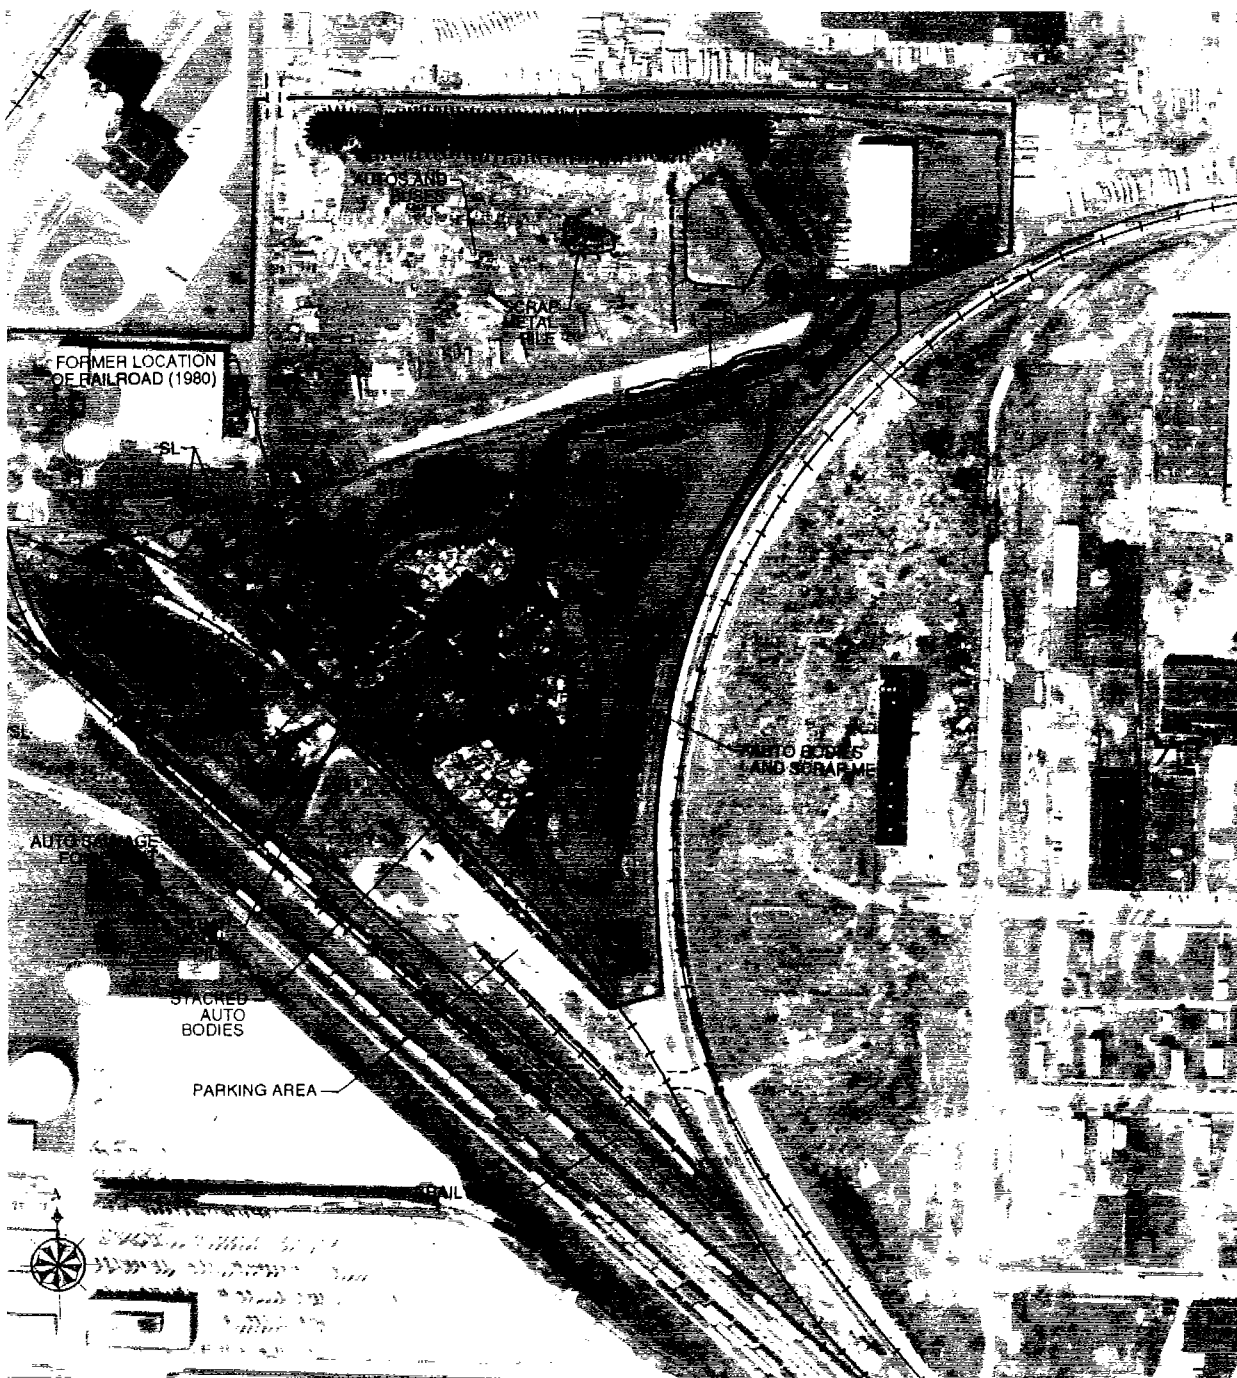
APRIL 7, 1988 (FIGURE 6)

The site continues to be in operation. Liquid-filled impoundment IM-1/SL again contains three cells. No changes are noted in liquid-filled impoundment IM-1/SL or impoundment IM-3. New material has been added to storage pile SP1 and has approximately doubled in size since 1987.

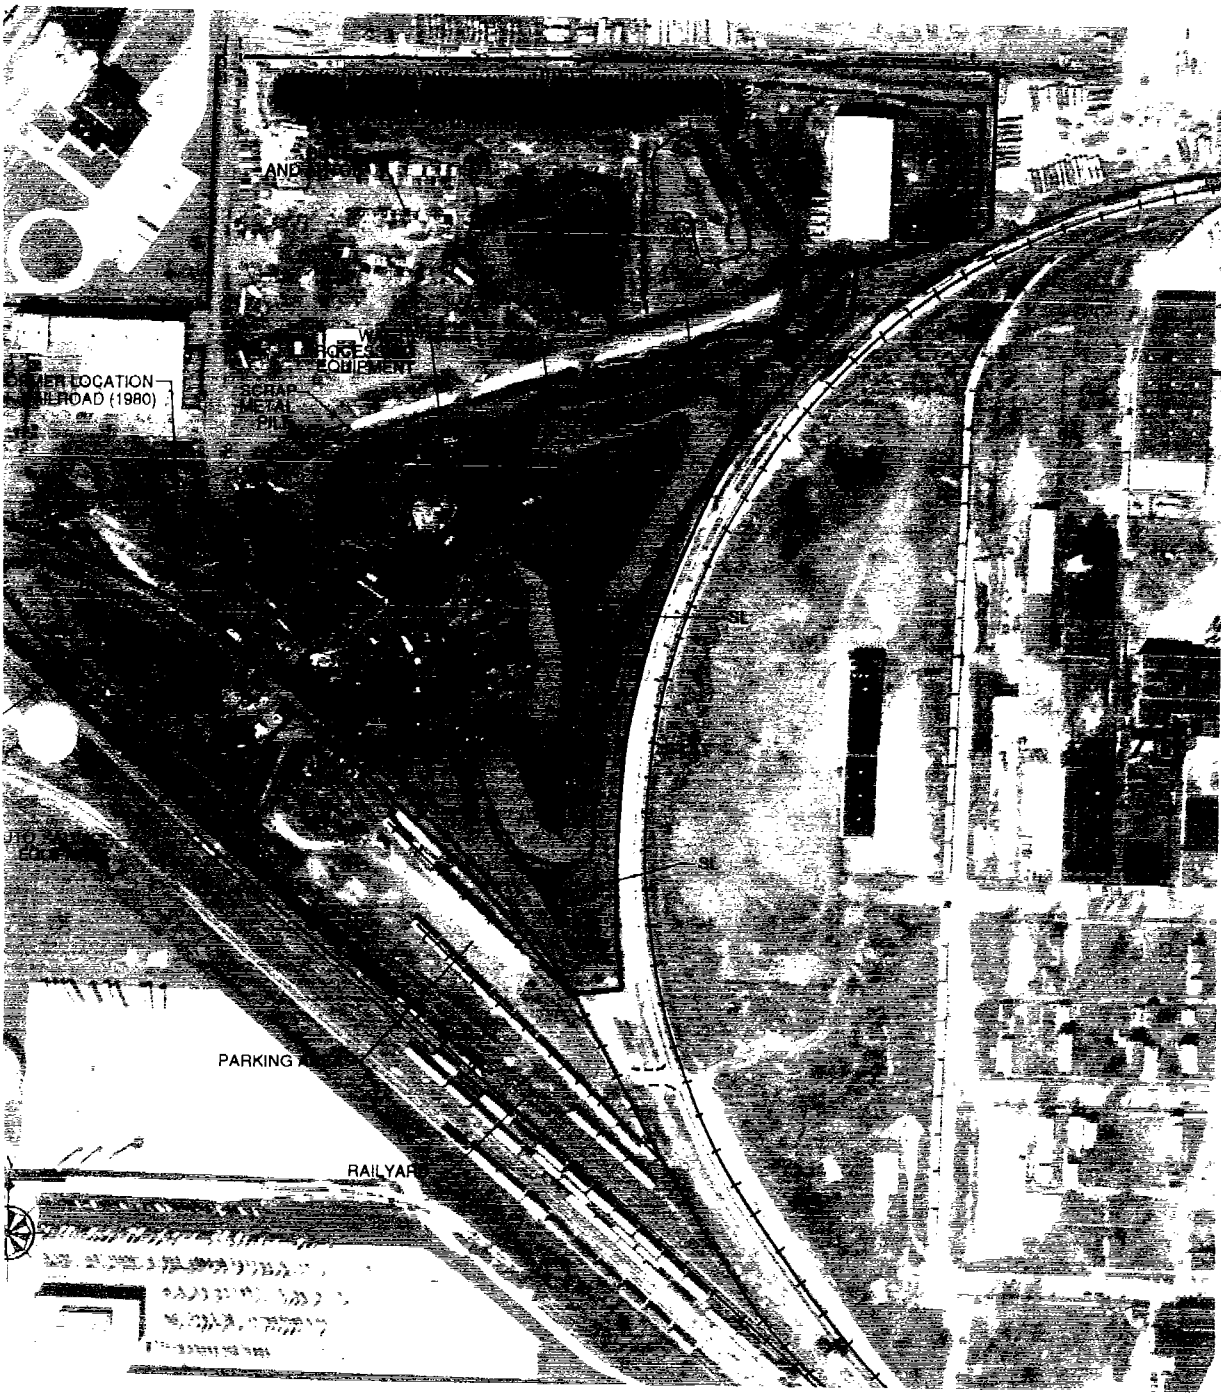
MARCH 20, 1990 (FIGURE 7)

The site continues to be in operation. No changes are noted in liquid-filled impoundments IM-1/SL and IM-2/SL or impoundment IM-3. Storage pile (SP1) has changed in shape since 1988. New waste processing equipment is visible south of the former location of the railroad.

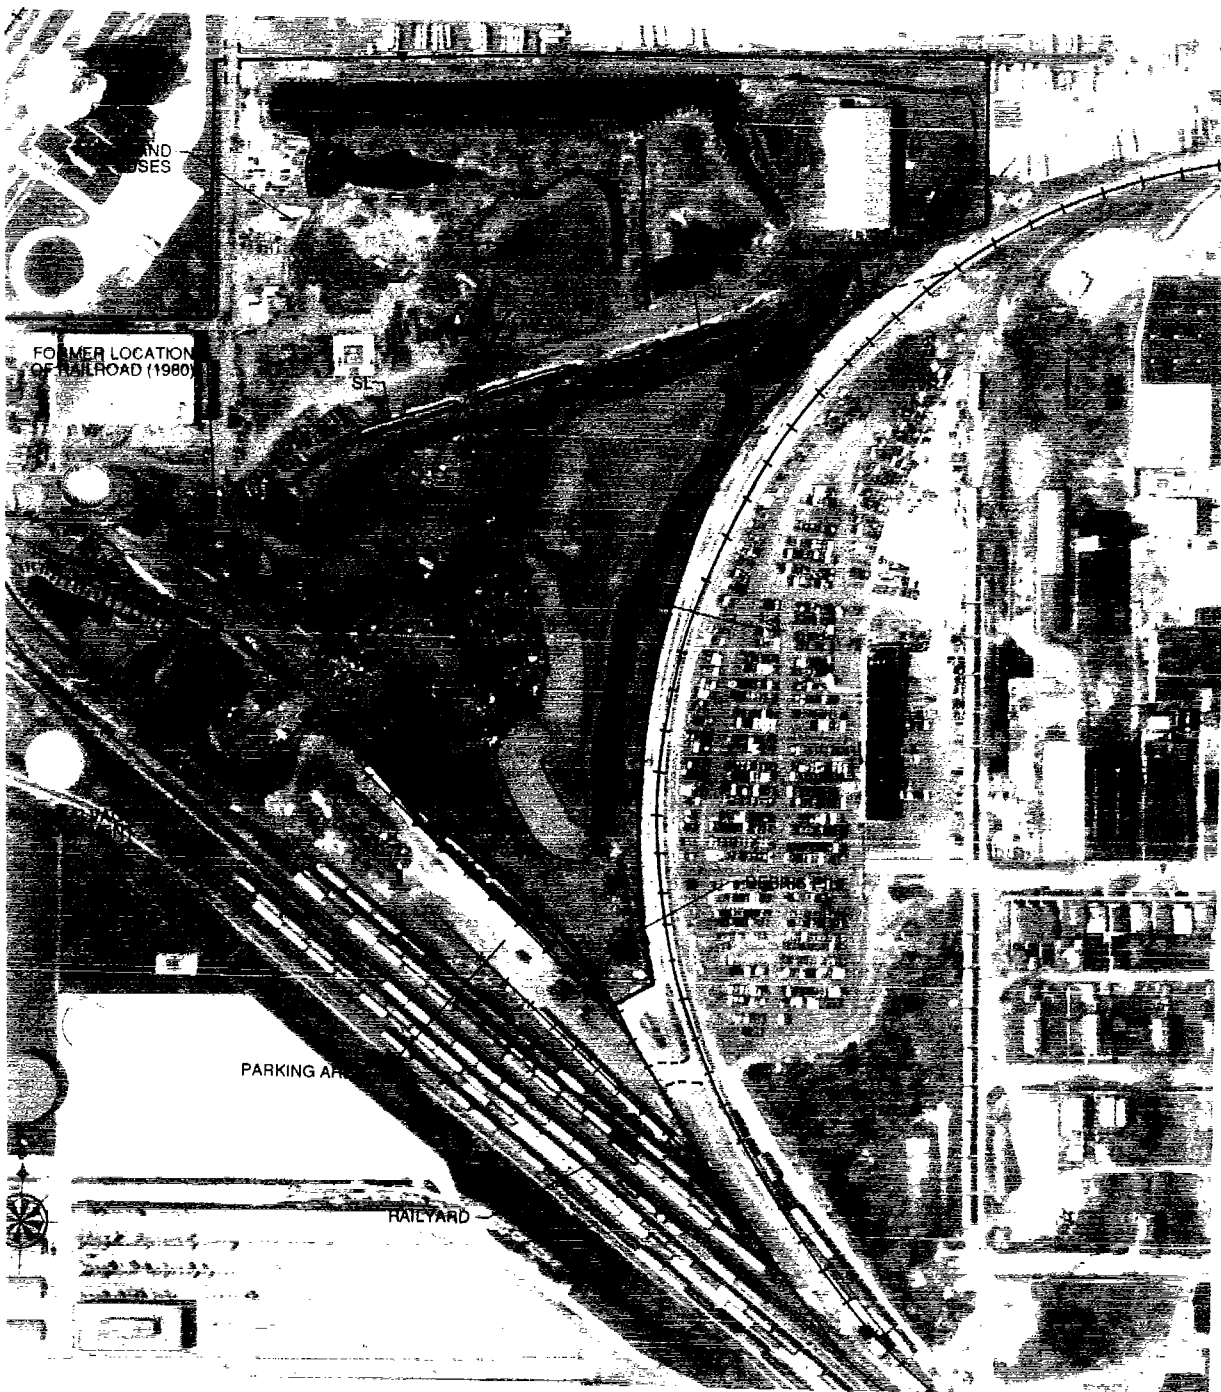
MAY 1, 1992 (FIGURE 8)

The site continues to be in operation. Liquid-filled impoundment IM-2/SL now contains two cells. The waste processing equipment noted south of the former railroad in 1990 has been removed. Liquid-filled impoundment IM-1/SL now contains two cells. No changes are noted in impoundment IM-3. Storage pile SP1 has changed in configuration since 1990.

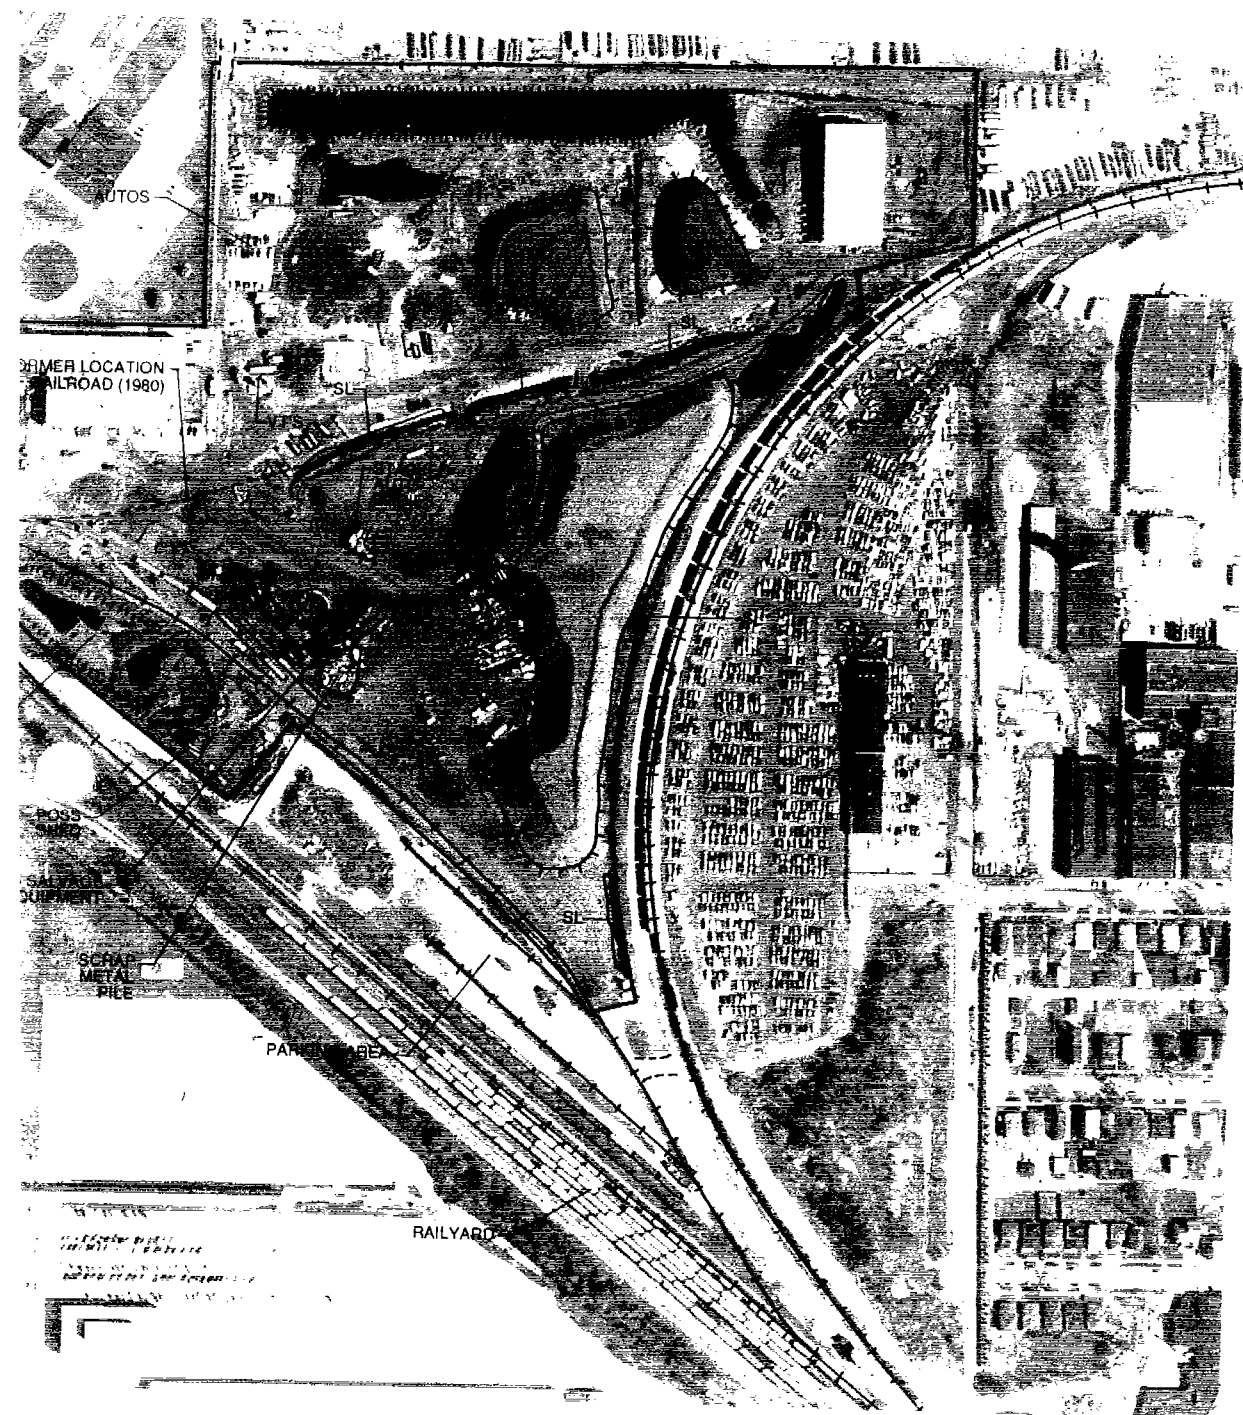
APRIL 20, 1994 (FIGURE 9)

The site continues to be in operation. Liquid-filled impoundment IM-2/SL now contains one cell. No changes are noted in liquid-filled impoundment IM-1/SL and the impoundment annotated IM-3 in 1992 now contains liquid and is annotated as IM-3/SL. Storage pile SP1 has changed in configuration since 1992.

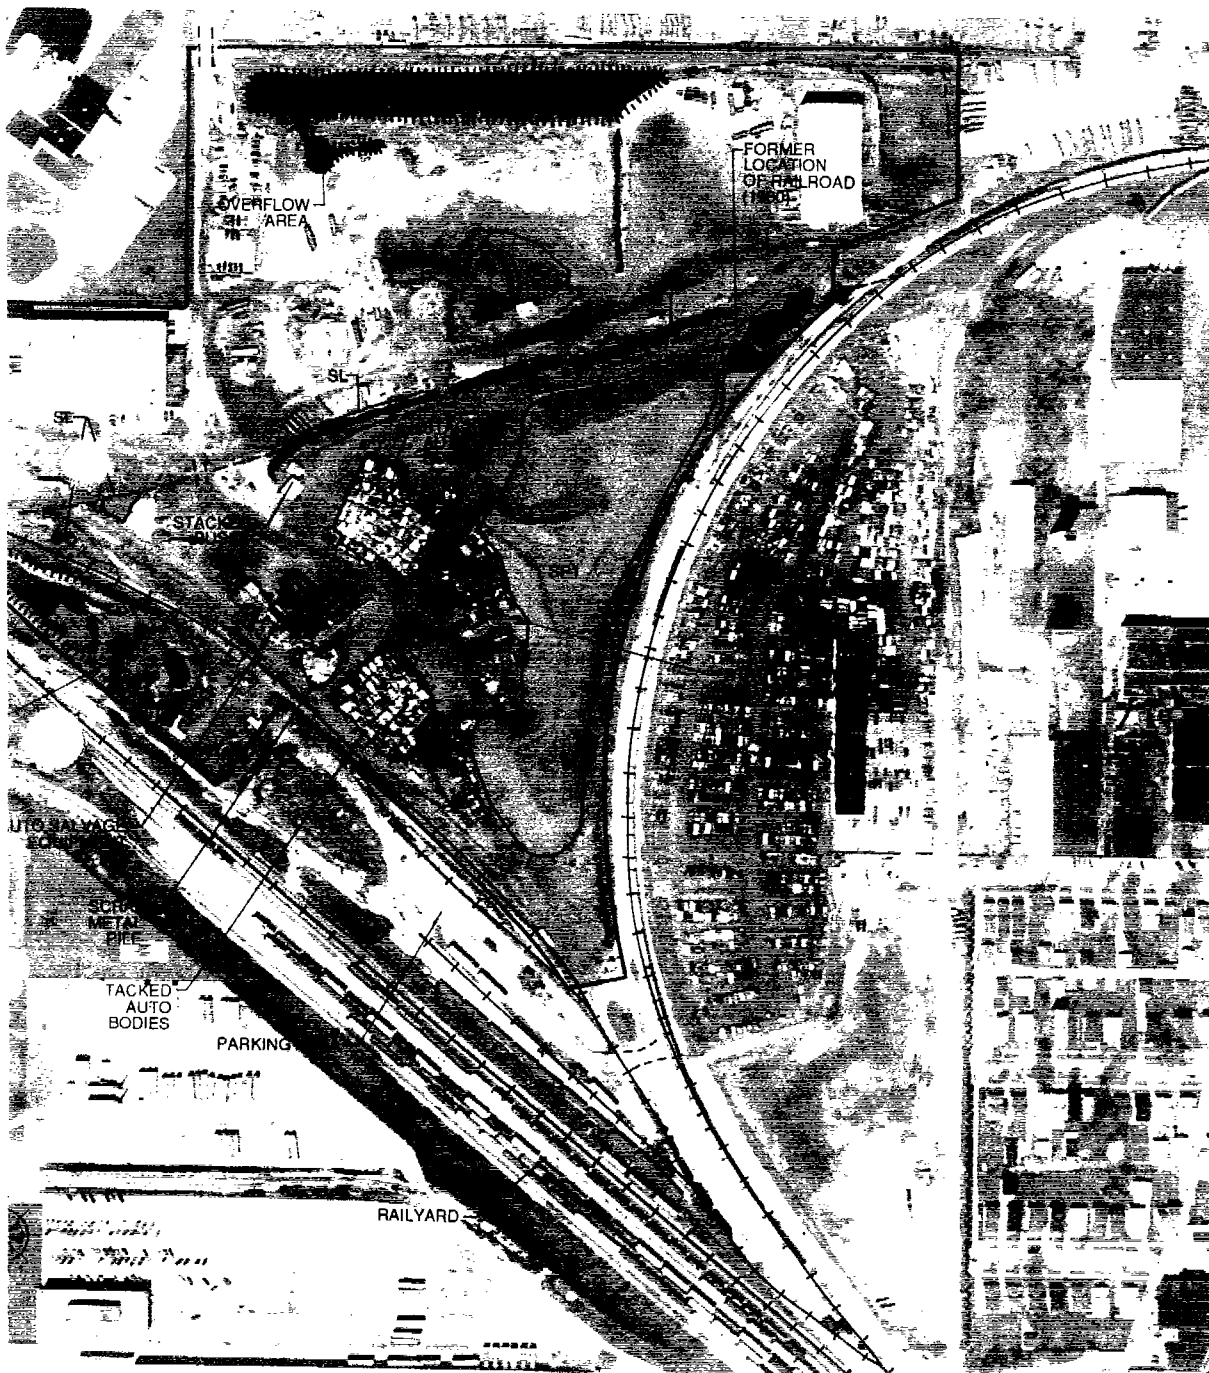
APRIL 2, 1997 (FIGURE 10)

The site continues to be in operation. Liquid-filled impoundment IM-2/SL has overflowed its berm and now extends to the area of standing liquid observed south of it in 1994. Another drainage segment which trends in a northerly direction toward the drainage segment previously observed, is visible at the northeast corner of the site. Liquid-filled impoundment IM-1/SL now contains three cells and the liquid-filled impoundment annotated IM-3/SL in 1994 is now dry and annotated IM-3. Storage pile SP1 has changed in configuration since 1994.

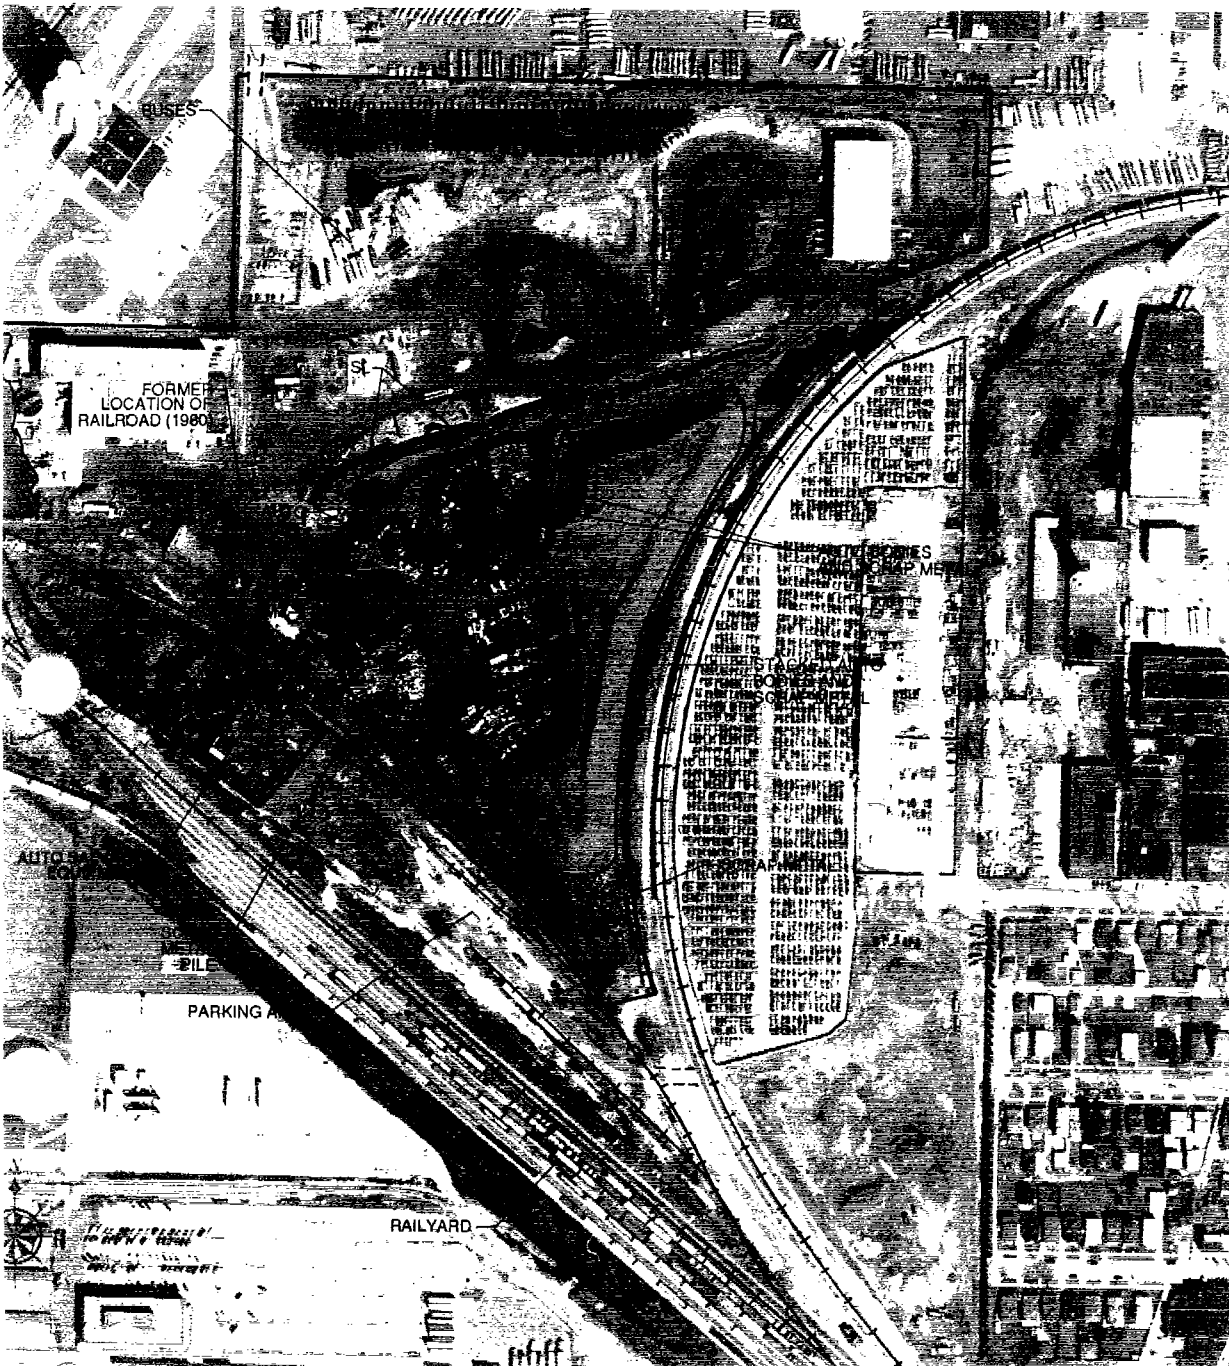
MARCH 24, 1998 (FIGURE 11)

The site continues to be in operation. Liquid-filled impoundment IM-2/SL has dried up slightly, leaving behind an area of standing liquid to the south of it. No changes are noted in liquid-filled impoundment IM-1/SL or the dry impoundment IM-3. No changes are visible in storage pile SP1.
